# Gympie Messmate how does it shape up at 27 years old?

***By: Sean Ryan PFSQ Executive Officer 2006***

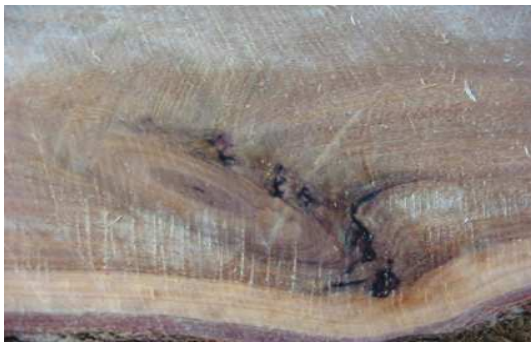
***Figure 1. Overgrown branch with ingrown bark resulting in a major structural defect***

Once the logs were opened up, a number of other problems sometimes presented themselves. Old branches were the worst defect with associated enclosed bark causing major structural defects. F14 structural timbers must be sawn without containing enclosed bark as the bark results in a fracture point which may result in service failure.

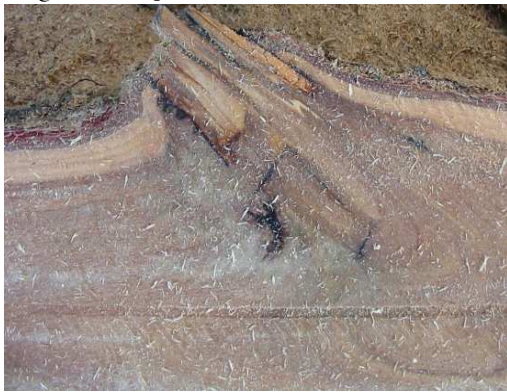
Exposed dead stubs were also a problem, often being associated with doze (soft rot) as the stub began to breakdown. In a number of cases this had begun to spread into the centre of the tree. This demonstrated the absolute requirement for pruning in a messmate plantation when the stem is less than 100mm in

diameter. It also demonstrates the potential downgrade (loss of up to 50% of the merchantable sawlog volume) that may be associated with any log not pruned above the six metre mark. In the process of sawing these logs, the level of downgrade confirmed the necessity to prune the messmate in my 5 year old plantation. Pruning for optimal product recovery to a minimum of 10 metres in height may be necessary in order to achieve a potential 15.5m poles (If this product is your primary product goal). Poles will fail the Australian pole standards if a defect of this magnitude is present.

*Figure 2. Branch stub with associated ingrown bark, this sometimes resulted in the development of doze that would travel into the centre of the log*
