# Gympie Messmate how does it shape up at 27 years old?

***By: Sean Ryan PFSQ Executive Officer 2006***

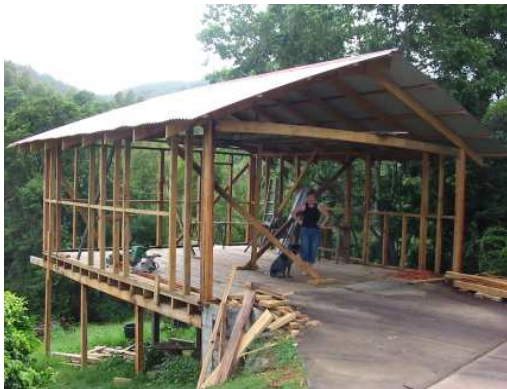
There were many positives, the heartwood was generally very straight and confined and resulted in minimum loss from associated heart encroachment. The sawn wood was clean and did not developed cell collapse or cracks as a consequence to drying. The timber worked well in accepting framing nails without splitting.

*Figure 3. Some of the sawn timber in a car port still at the framing stage*
